butte landing

AREA STRUCTURE PLAN

TITLE Butte Landing Area Structure Plan

VERSION/DATE DRAFT - JANUARY 2024

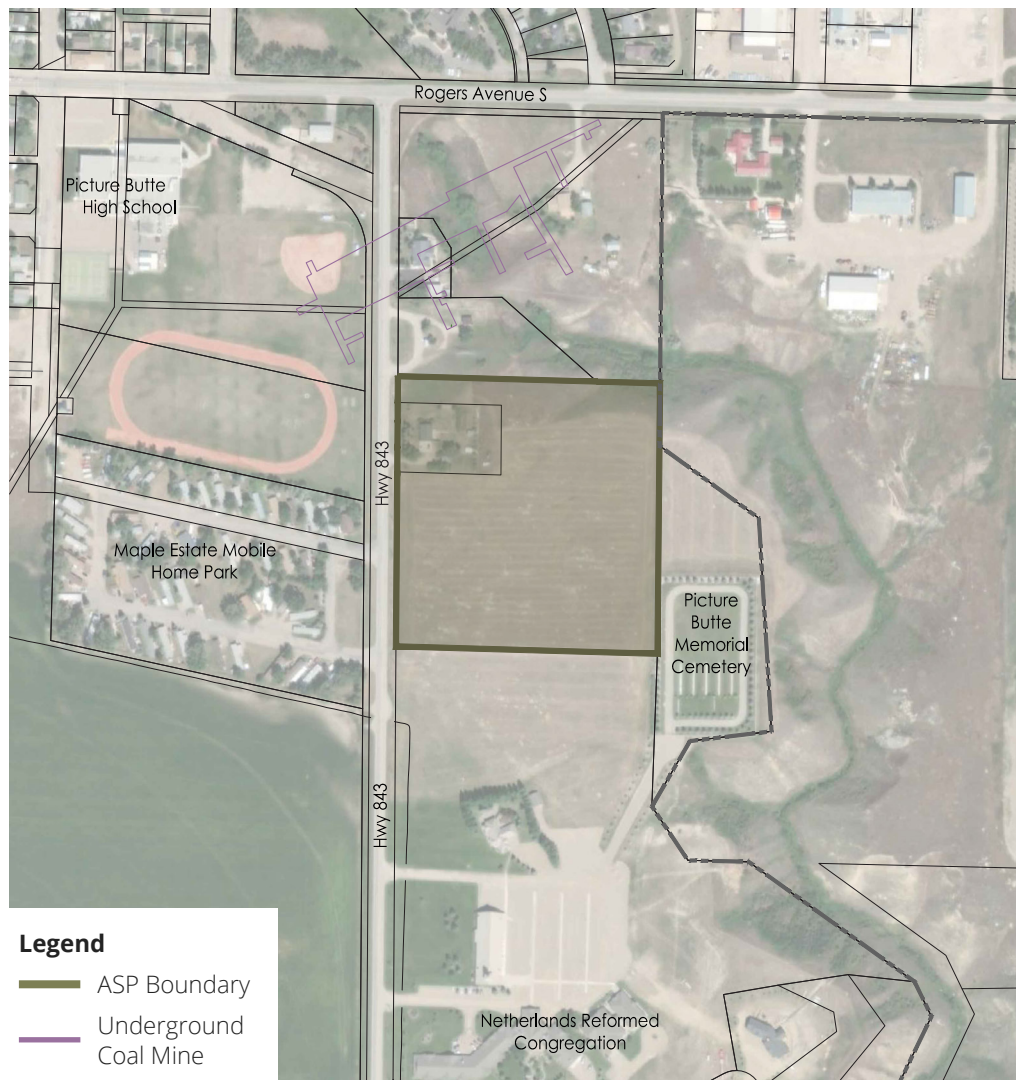
Map 2 Site Context

Agricultural pursuits are observed to be the predominant land use utilized within the southern half of the Town, more specifically south of Rogers Ave S, although the area has been identified within the MDP for urbanization and development through the adoption of ASPs. An underground coal mine owned by Northern Coal Co. Ltd (Mine Number 1414) is located north of the Plan Area, however, this mine has been abandoned and is no longer active.

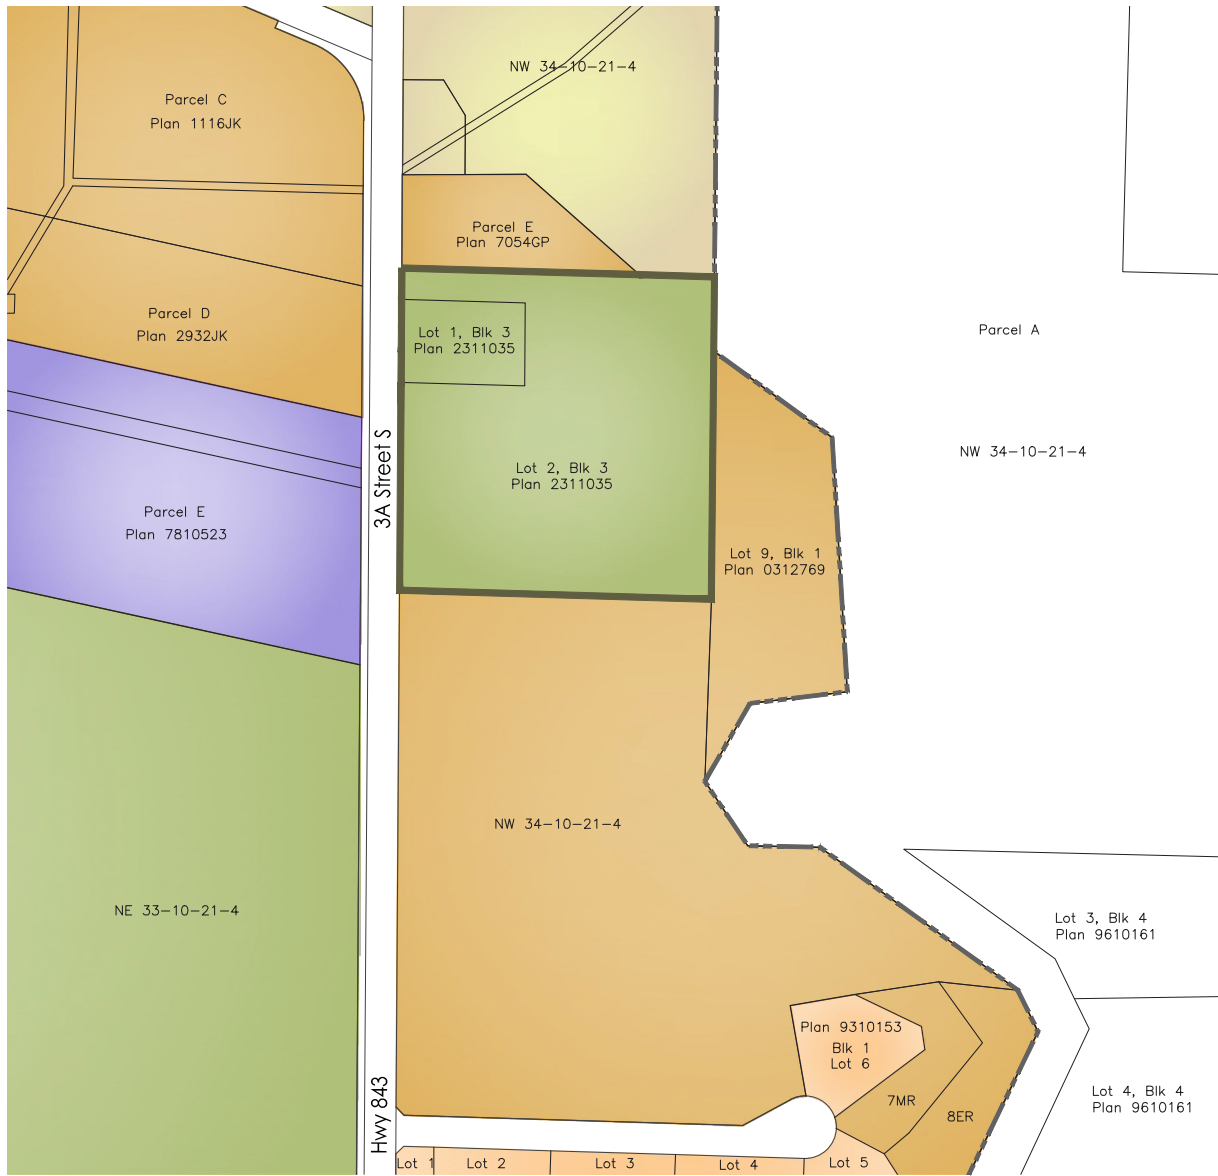
Map 5 Existing Land Use

Uses adjacent to the Plan Area include a mix of agricultural, residential, and public service uses, including the Maple Estate Mobile Home Park, Picture Butte Memorial Cemetery, Netherlands Reformed Congregation, Bethesda Home for Seniors and the Picture Butte High School.

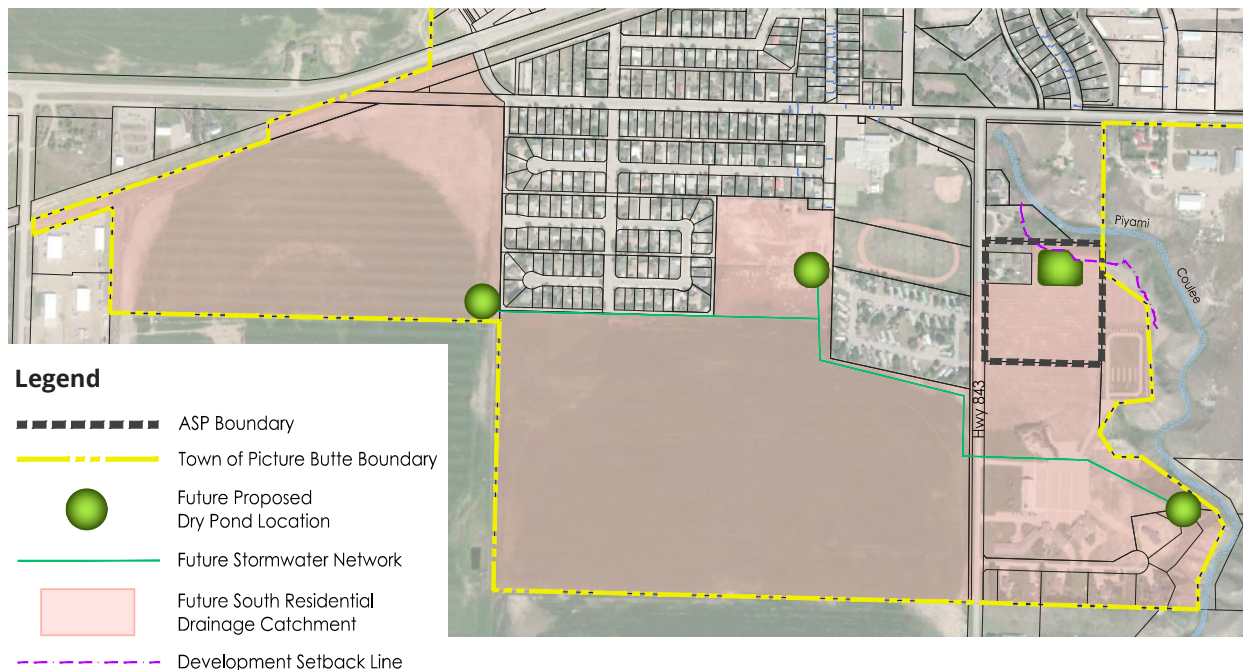
Map 10 South Residential Drainage Strategy

Regardless of the outfall option that is chosen for the development, Butte Landing will incorporate a stormwater management system that conveys, treats, and attenuates urban development flows to pre-development conditions using a minor storm sewer system and a major storm system that manages surface run-off during extreme rainfall events. All parcel and lot grading plans shall conform with the overall stormwater management plan as required by the Town at the subdivision or development stage.

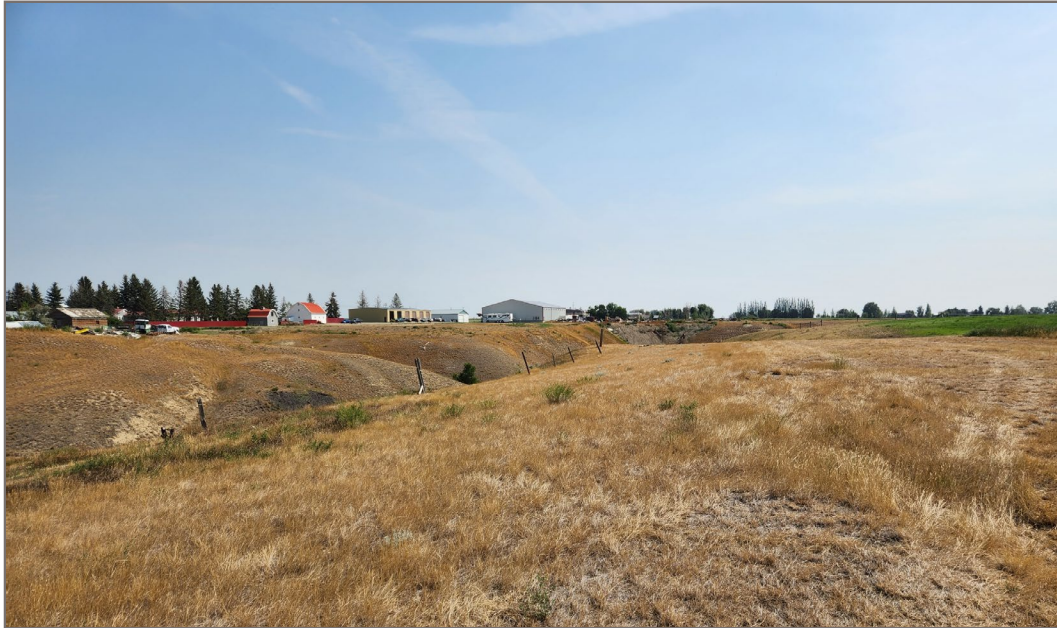
Photo 1: Northwest End of the Site – Facing East.

The site is located at prairie level within the southeast portion of the town limits of Picture Butte, Alberta, adjacent to Highway 843 to the west and the Picture Butte Memorial Cemetery to the southeast. The site is currently hay land with partial development on the northwest corner, approximately 3.72 ha. in area (Figure 2). The overall site drains towards the northeast corner which abuts sideslopes of an Oldman River tributary coulee (Photo 1 through Photo 4).

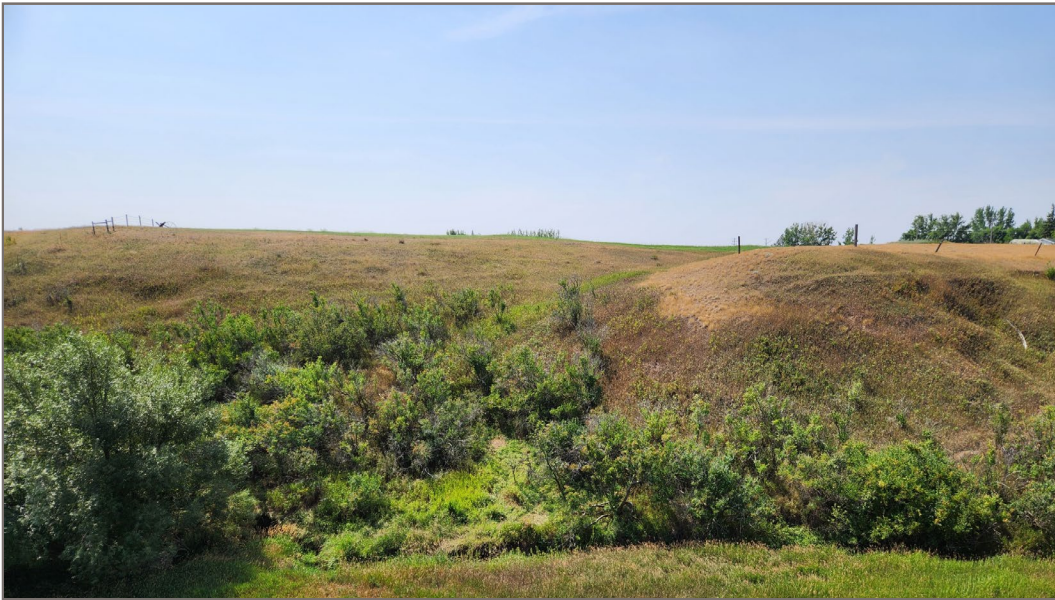
Photo 3: Across Tributary Coulee – Facing South Toward the Site Slope.

- Groundwater seepage was not visible along the slopes; however, areas of lush vegetation were present along the slopes which may be an indication of high moisture condition of the slope soils (Photos 3 and 4). Two culverts were visible within the tributary coulee; one was present upstream of the tributary coulee (Photo 5), while another culvert was visible north of the site at the toe of the site slope surrounded by rip-rap (Photo 6).

- Historical slope instability was evident along the upper portion of the slope face directly north of the site in the form of slumping (Photos 4 and 8).
- The entire slope north of the site was well vegetated by grass and shrubs, with trees located nearer to the toe of the slope (Photos 3, 4, 6, and 7).

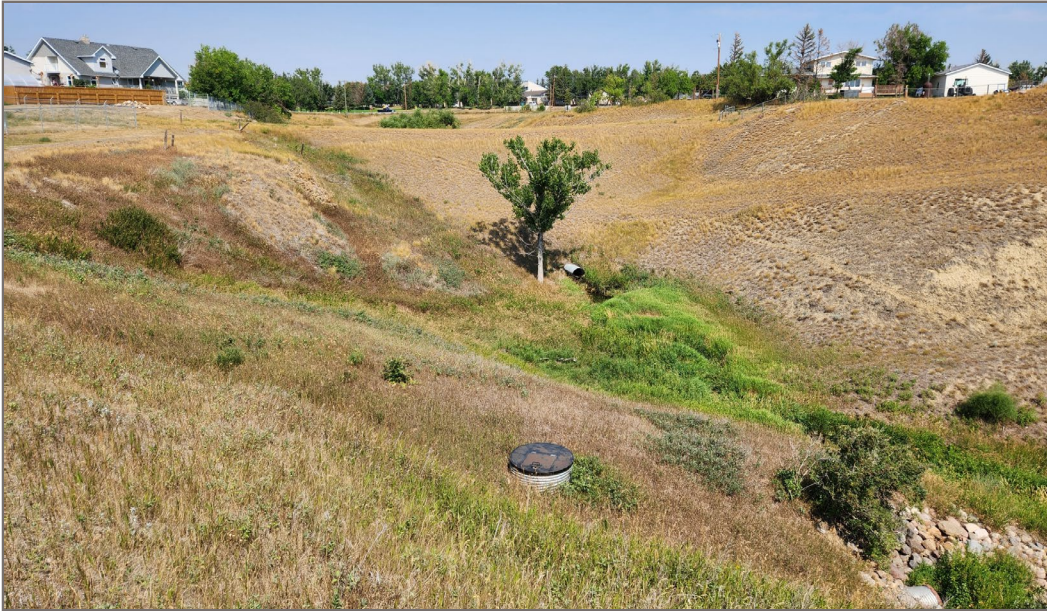
Photo 5: Culvert Upstream of the Tributary Coulee.

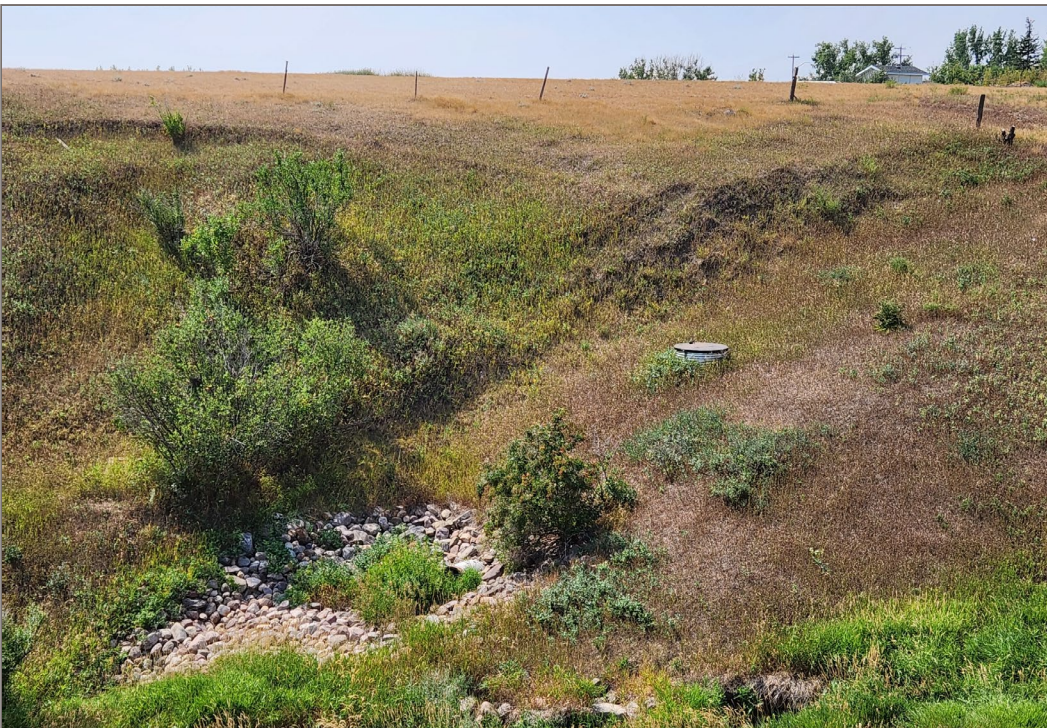
Photo 6: Culvert Along Site Slope.

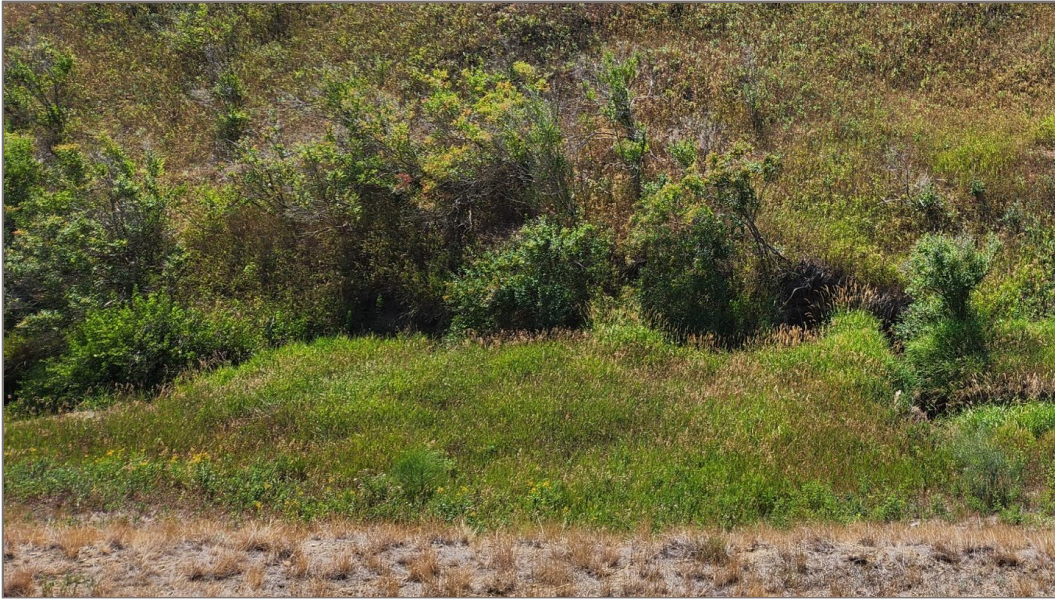
Photo 7: Channel Visible at the Toe of the Site Slope – Facing South Across the Tributary Coulee.

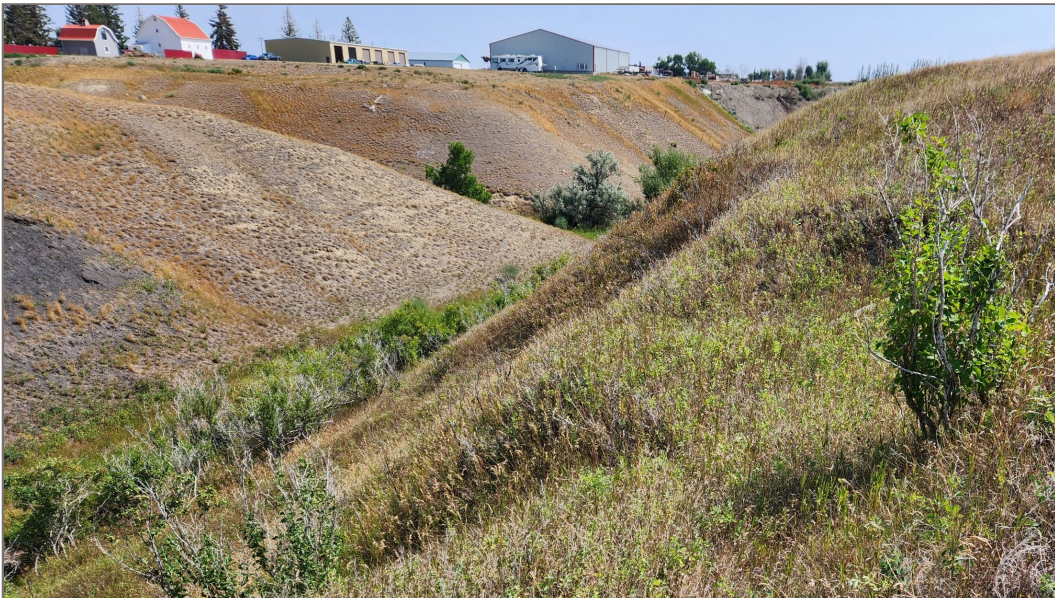
Photo 8: Historical Instability on Slope North of Site – Facing East.

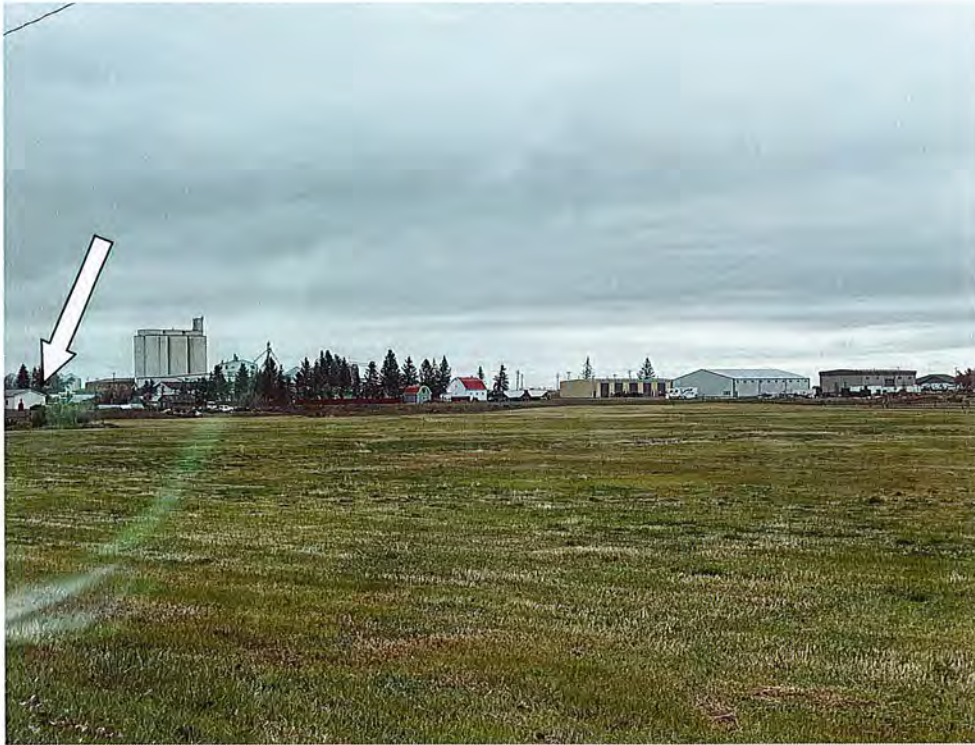
*Photograph 1: Looking northeast at the subject site from Secondary Road 843
Note: Residence located in the northwest corner of the site (arrowed).*

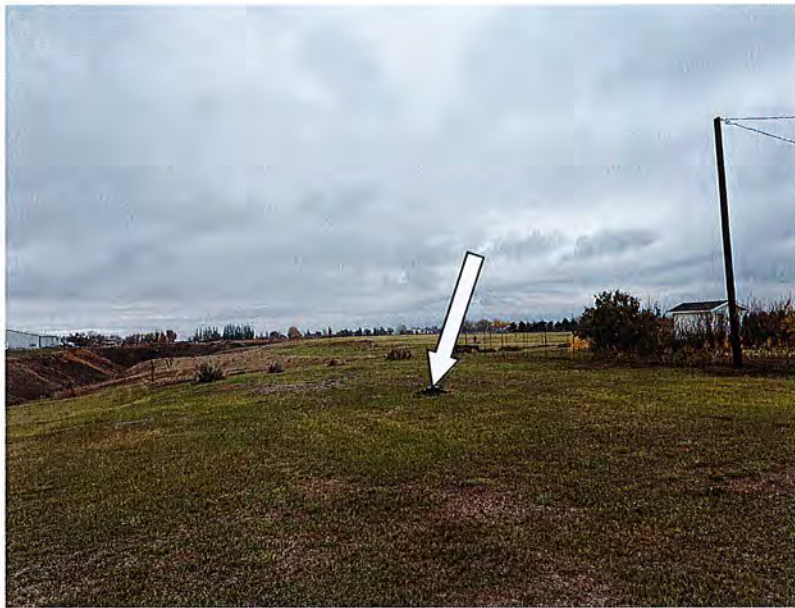
Photograph 2 – Looking east along north property line. Note catch basin Previously installed in preparation for storm sewer connection (arrowed)

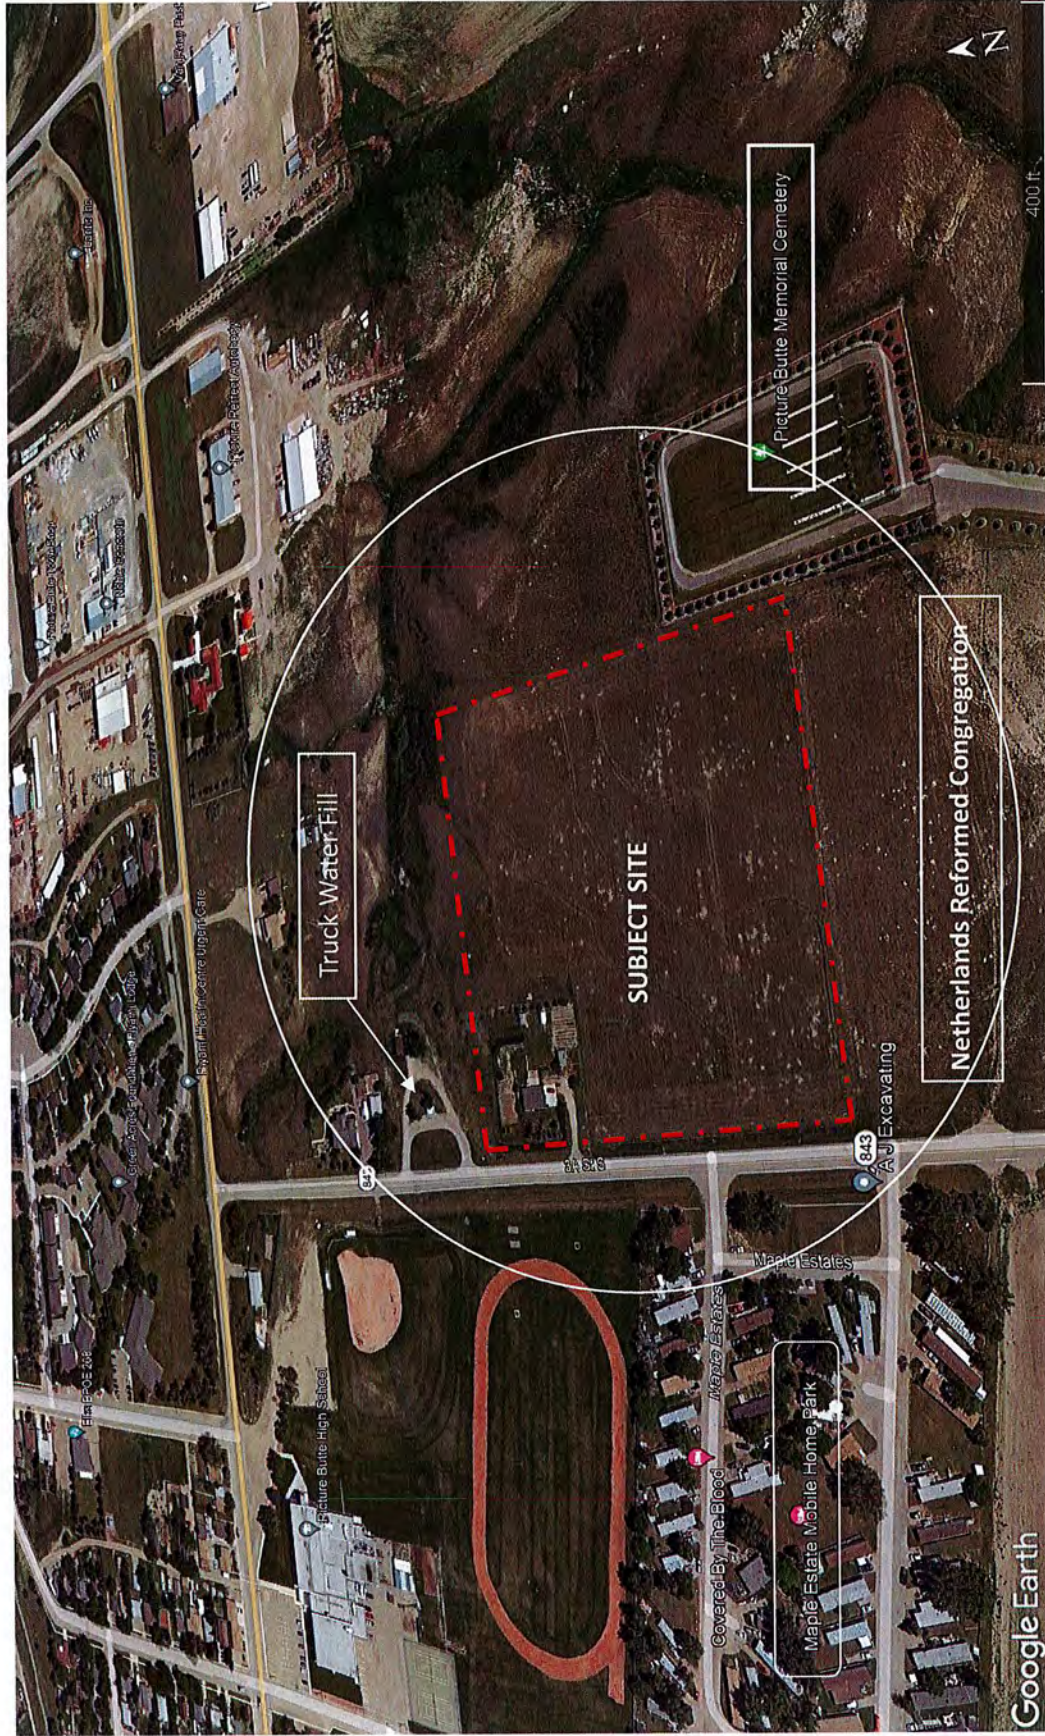
<p>Project: Phase I Environmental Site Assessment</p> <p>Location: Lots 1 & 2, Block 3, Plan 2311035 Picture Butte, Alberta</p>	<p>Project: WA-23-101402</p> <p>Drawn By: TGW Reviewed By: BFW</p>	<p>Date: October 17, 2023</p> <p>Client: Butte Landing</p>
<p>Drawing 2: Site Location Plan: Site Plan Showing Adjacent Land Use</p>

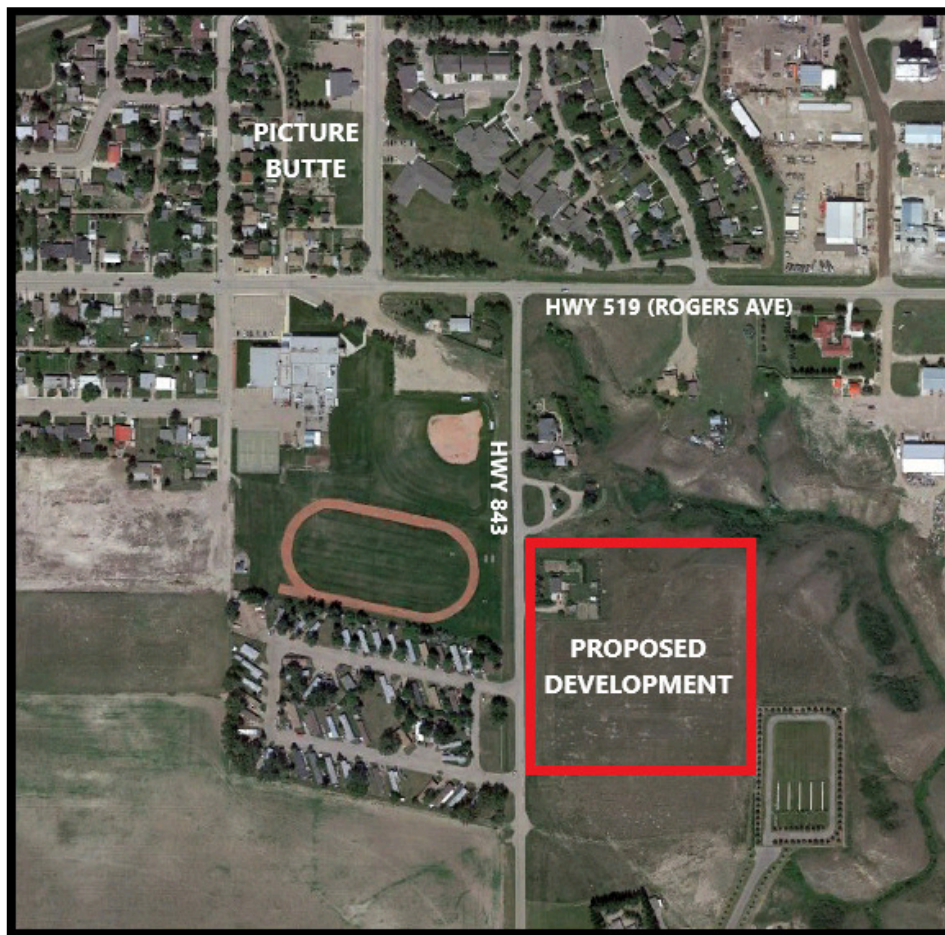
Figure 1: Site Location

Stantec Consulting Ltd. (Stantec) is undertaking a Traffic Impact Assessment (TIA) for the proposed residential development by Oak Pointe Inc., in Picture Butte, Alberta. The subject area is located adjacent to Highway 843, approximately 350 metres south on the intersection of Highway 843 and Highway 519 (Rogers Avenue). **Figure 1** illustrates the location of the site within the town of Picture Butte.
